Service Bulletin No. 211, Rev. A

Aircraft Starter Power-Lead Inspection

- (1) Hartzell Engine Tech has discovered that affected starter models, when installed on engines containing a fuel injection servo with a top mounted 90° fuel fitting, may have an improper installation.
- (2) This SB is to advise the field of a potential condition and to supply inspection criteria to identify proper and improper starter installations.

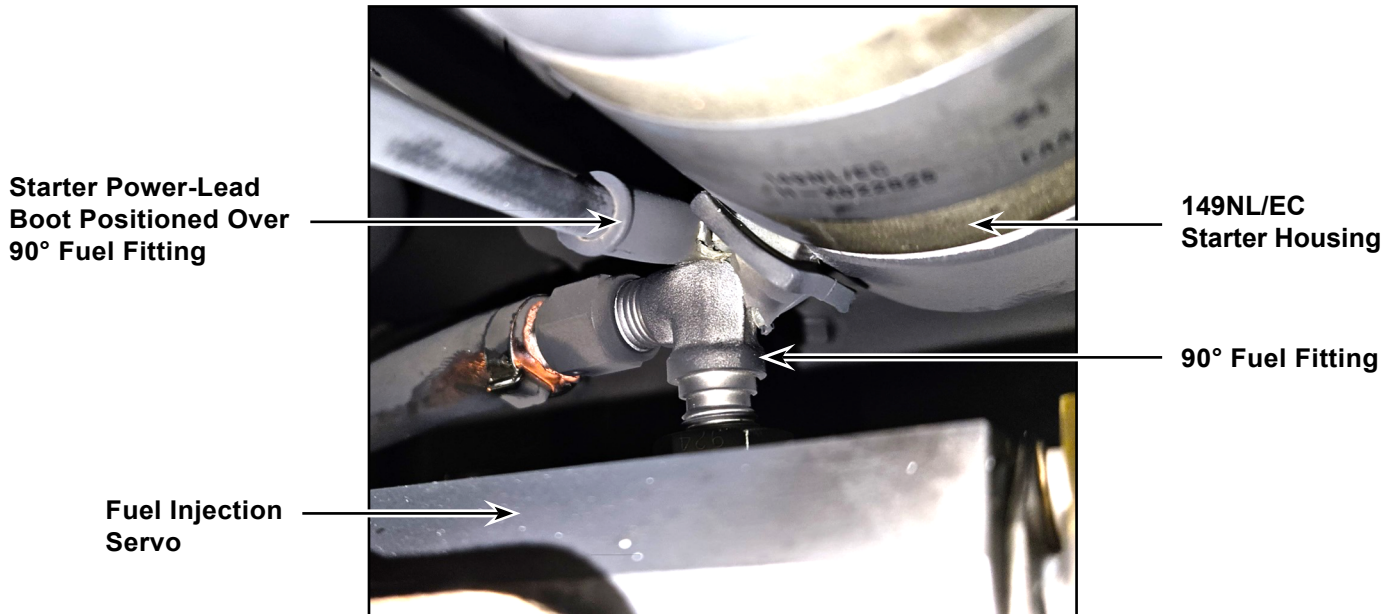
1) Starters found with an improper installation (Fig. 1):

b) Visually inspect the starter power-lead and boot for damage, e.g., chaffing, tears, heat damage, or exposed wire core.

Figure-1 - **Improper** Starter Installation

a) Remove the starter assembly in accordance with the latest aircraft/engine maintenance manual and service instructions.

1: If the starter power-lead and/or boot **is** damaged, replace the starter in accordance with the latest aircraft/engine maintenance manual and service instructions.

2: If the starter power-lead and boot are **not** damaged, re-install the starter onto the engine.

WARNING: TO PREVENT DAMAGE TO THE STARTER AND/OR AIRCRAFT, ENSURE TO POSITION THE STARTER POWER-LEAD BOOT BETWEEN THE FUEL INJECTION SERVO 90° FUEL FITTING AND THE STARTER HOUSING, AS SHOWN IN FIG. 2.

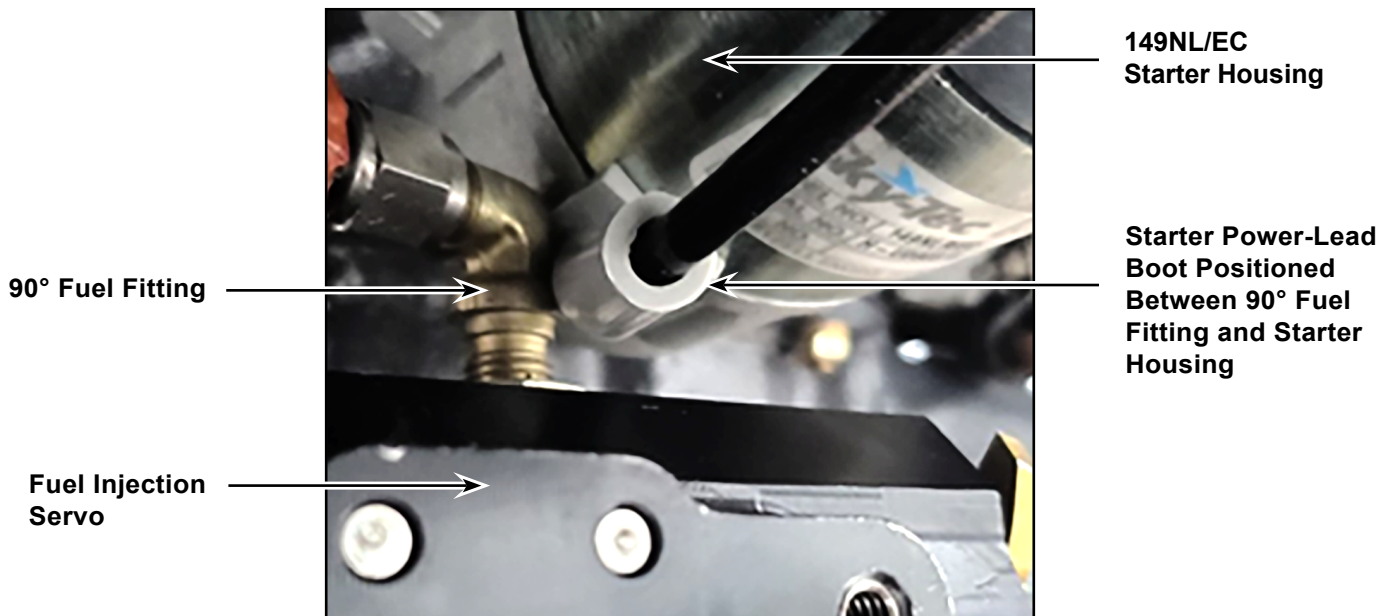
2) Starters found with a proper installation (Fig. 2):

a) Inspect the starter power-lead and boot for damage, e.g., chaffing, tears, heat damage, or exposed wire core.

Figure-2 - **Proper** Starter Installation

1: If the starter power-lead and/or boot **is** damaged, replace the starter in accordance with the latest aircraft/engine maintenance manual and service instructions.

WARNING: TO PREVENT DAMAGE TO THE STARTER AND/OR AIRCRAFT, ENSURE TO POSITION THE STARTER POWER-LEAD BOOT BETWEEN THE FUEL INJECTION SERVO 90° FUEL FITTING AND THE STARTER HOUSING, AS SHOWN IN FIG. 2.

2: If the starter power-lead and boot are **not** damaged, continue to 3.B(2), Recurrent Inspection.

1) At each regularly scheduled aircraft inspection or engine maintenance event, inspect the starter power-lead and boot for damage, e.g., chaffing, tears, heat damage, or exposed wire core.

a) If the starter power-lead and/or boot **is** damaged, replace the starter in accordance with the latest aircraft/engine maintenance manual and service instructions.
